Deutsches Schifffahrtsmuseum

The river barge **KARL VON BREMEN** of 808 AD

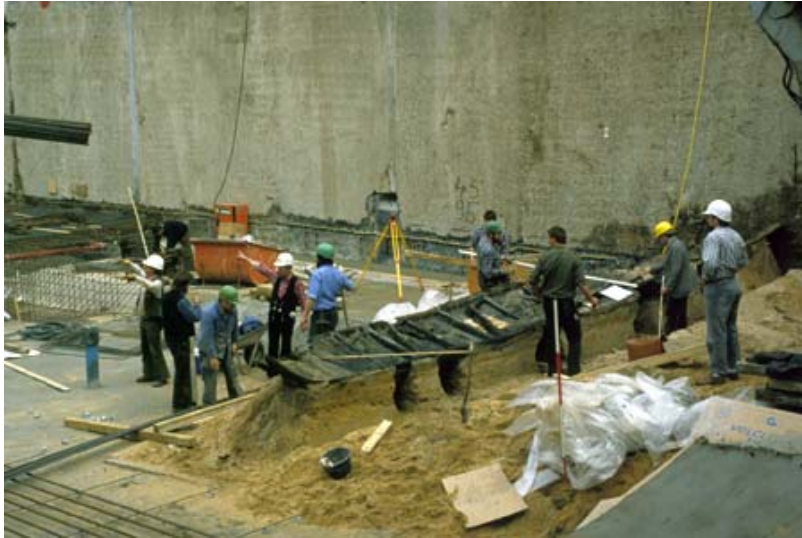
While excavating the building site for a new hotel near the river Weser in Bremen, the construction workers exposed a wooden boat, 10 m below street level, on March 29th, 1989. One end of the boat disappeared in the concrete wall of the building pit.

The boat had no iron nails or rivets, only wooden dowels held the timbers together. The outer planks of the flat bottom were L-shaped in cross-section: This sort of planks was used centuries ago to connect the bottom of boats with its sides. A colleague from the State Archaeological Department phoned us, and together we could salvage 12 m of the boat; presumably 5 to 8 m still lie outside the building site beneath the street.

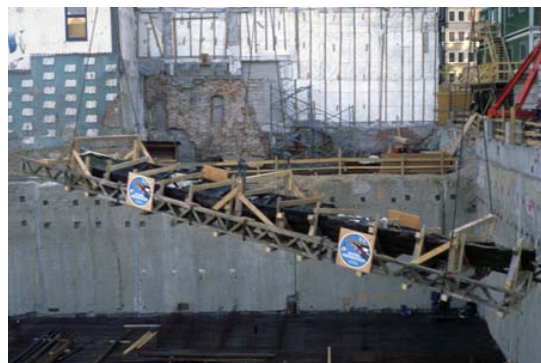
The river barge **Karl** is a very important find: From the Carolingian period only three other plank-built boats are known throughout Europe.

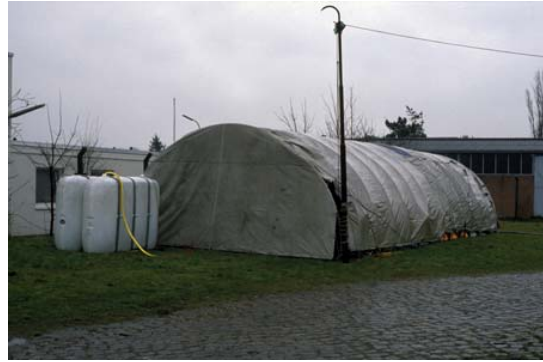
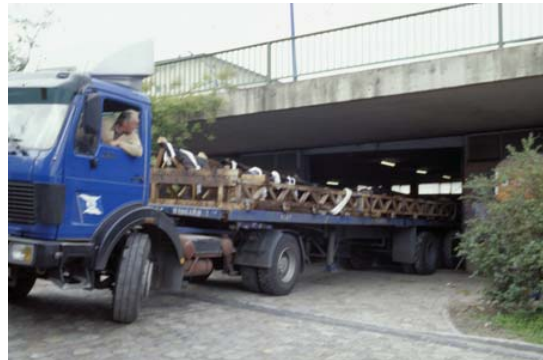
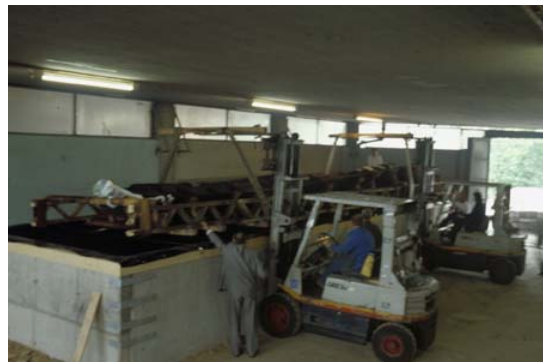
A frustrating year went by. From more than one hundred companies, private persons, and the foundation Wohnliche Stadt we collected 90.000 Euros. In an extensive search we found a place in a hall under a bridge and had a conservation tank built there. The money did not cover all necessary installations, but **Karl** suffered in his tent: The summer was long and hot, and we had to submerge the ship in conservation solution lest it would break to pieces.

We treated **Karl** with the **two-step PEG-impregnation** which we had developed to stabilise the Bremen Cog. The impregnation took eight years.

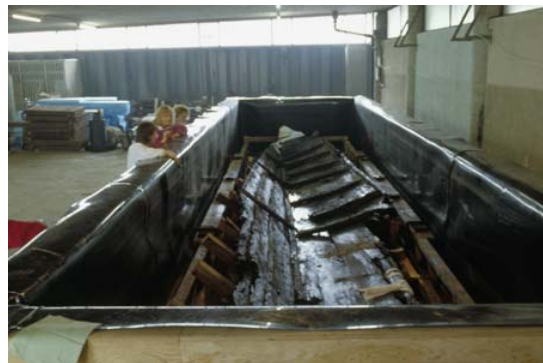
We had to build the ship anew. All members were loose: Frames broken, wooden dowels sheared off partly already in the river bed, partly during the transport after the salvage.

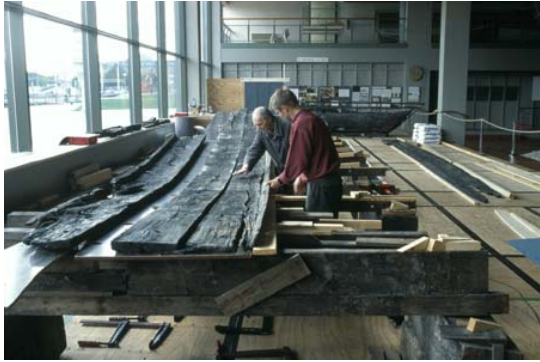
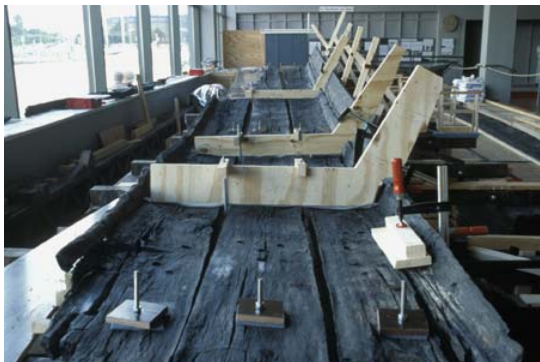
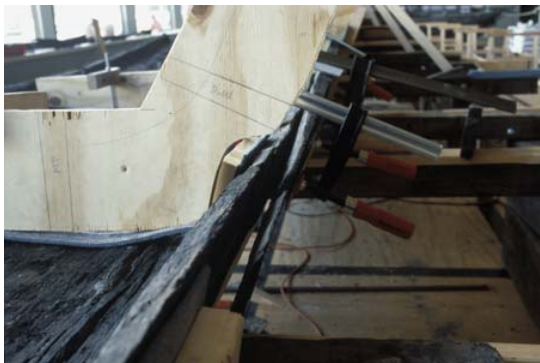
We placed the three bottom planks on a strong plywood base plate so that they would not sag with time. The base plate was adjusted to the curve of the outer bottom planks. The stabilisation of the timbers had not turned out as good as hoped for – due to insufficient funding of the project which had compelled us to buy too cheap a heating system. Planks which had warped during and after impregnation were heated and pressed back into their original shape.

We erected provisional frames to build up the side planks. The port side of the ship is mostly preserved, from the starboard side great parts are missing. Each side is built from three wide clinker-set planks. The width of the ship will have been 220 to 240 cm, the height of the sides amid ship about 75 cm.

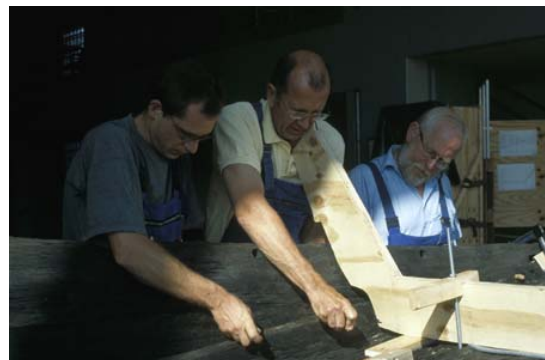
We put new dowels into the old holes. It seems that 1200 years ago shipwrights had just been working on the fastening of the frames to the planking when **Karl** sank in the river, maybe in a flood: Many of the dowels protruded 1-2 cm from the underside of the ship; they were not yet cut flush with the hull.

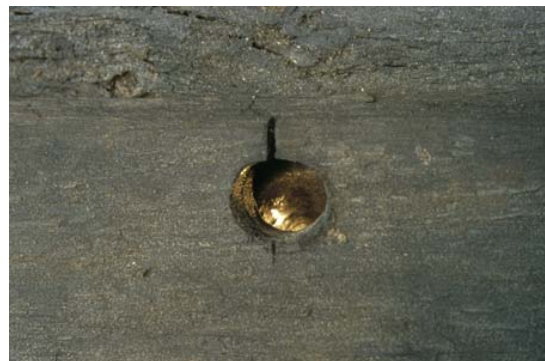
We found other indications that **Karl** had undergone some repair or reconstruction: Dowel holes have been plugged with moss, some are not aligned, others have no correspondence in the overlapping timber. We do not know how **Karl** was propelled. Maybe he was punted along the shallow waters of the slow running river.

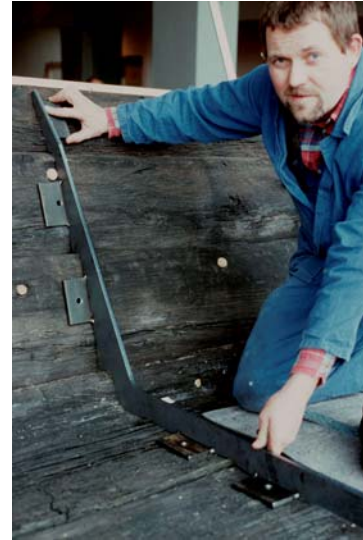
Exact wooden frame templates were fitted to the places of the original half-frames, and then executed in 10 mm steel. To the steel frames are welded flange plates over the original dowel holes.

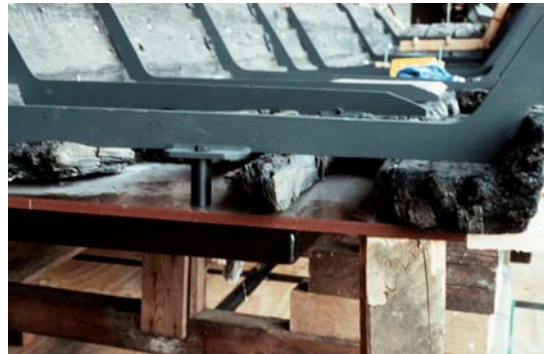
Steel plates are fixed under the plywood base plate, and against them the steel frames are screwed. Pieces of steel tube in the original dowel holes keep them at distance, so that no pressure is exerted on to the old wood when the screws are tightened.

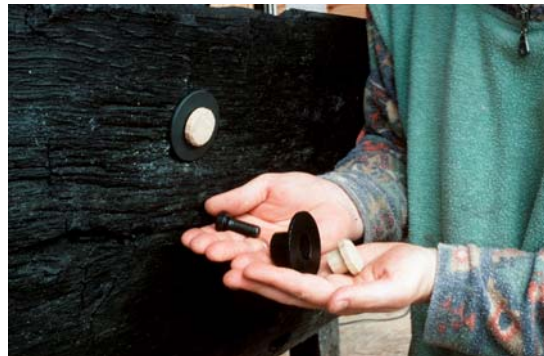
The side planks are fastened to the steel frames with nuts that resemble inverted top hats: The nut is in the top, the rim holds the plank, and into the hollow we put short wooden dowels to resemble the original dowels. Again, we use the original dowel holes. We placed the original frames alongside the steel ones.

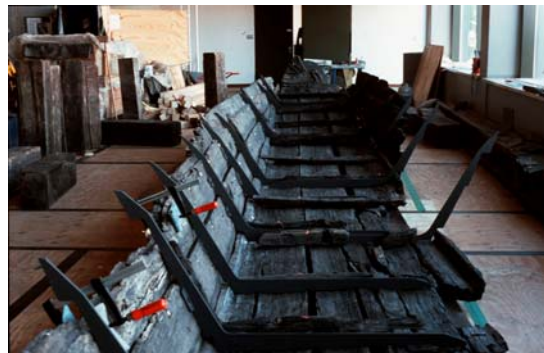
The plywood base plate rests on two steel stringers bent to follow the rising curve of the boats bottom. A steel plate supports the bow-plate of the boat which holds together the ends of the bottom and side planks. Where the garboard is missing we have outlined its upper edge with a steel profile to give an impression of the volume of the big boat.
